Preliminary Field Report: Rapid Damage Assessment Following the M6.3 Earthquake on October 3, 2023 in Bajhang, Nepal

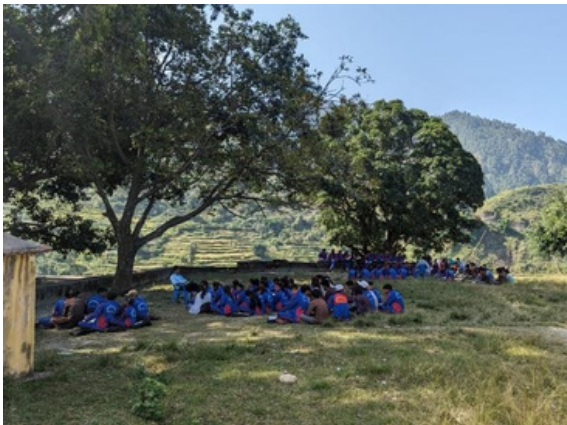
Classes are being run out of classroom

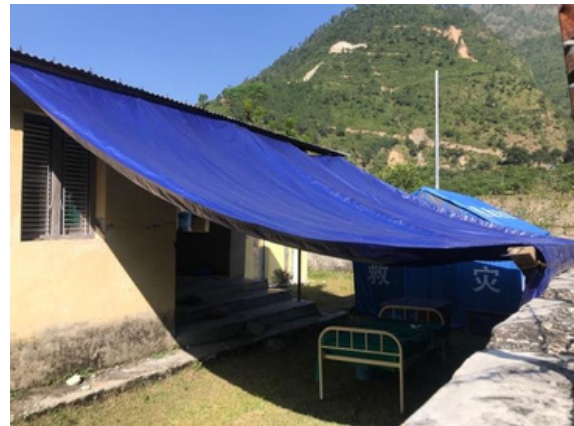
Childbirth is being carried out openly as the health center is damaged

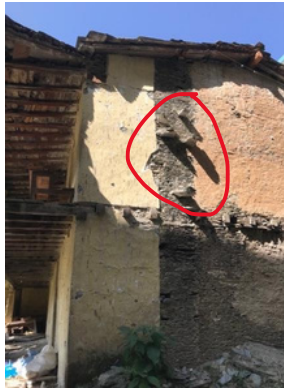
The oldest building in Satyabadi Secondary School (Established in 1963 BS) found to perform well. These building are also made up of stone masonry in mud mortar. Earthquake resistant element such as horizontal timber band, wooden pegs at beam joints to restraint horizontal movement and corner stones were observed. Traditional building technology in this region were also found to be earthquake resistant. We shall promote these traditional technology with additional knowledge gained from research for further reconstruction, recovery as well as in new constructions.

Corner stones are placed in traditional construction technology

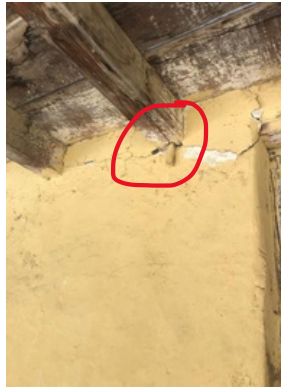
Wooden pegs in beam and wall connection to restrain the horizontal movement

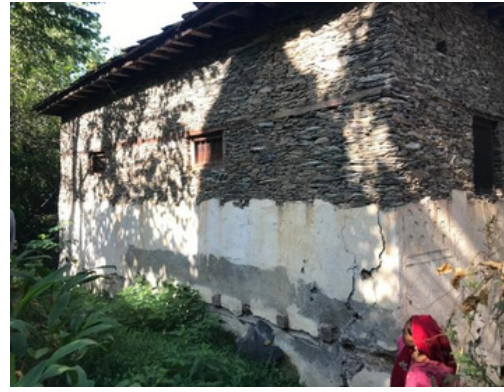
Buildings with timber bands performed well
